THE LATIN PATRIARCHATE
OF JERUSALEM

Conclusion Report

Structural Repairs at Rafidia Church and Hall, Palestine

GA 241/20

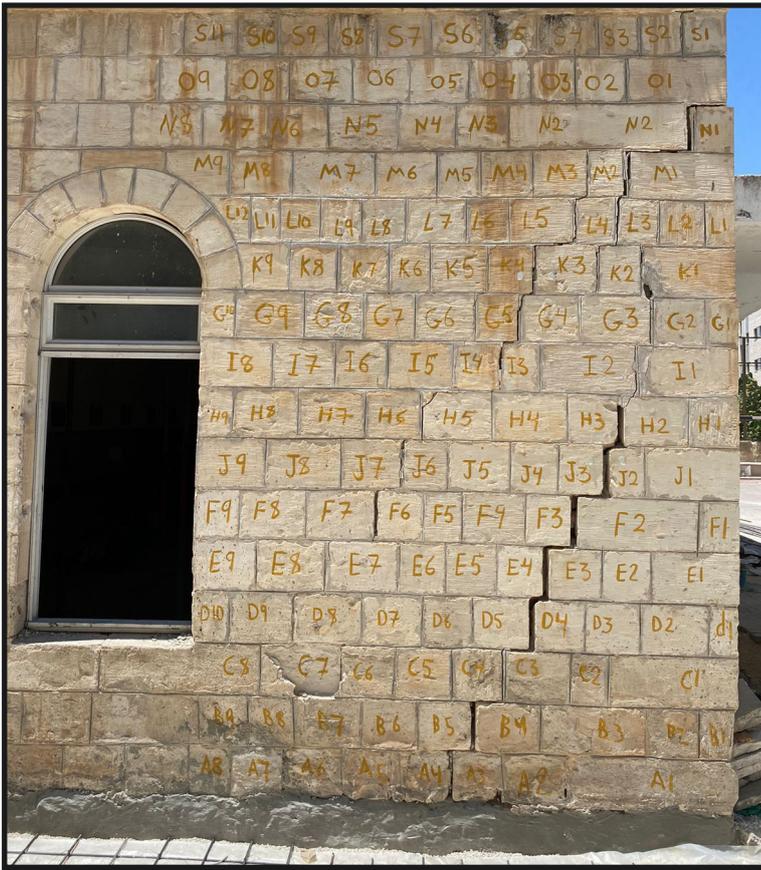
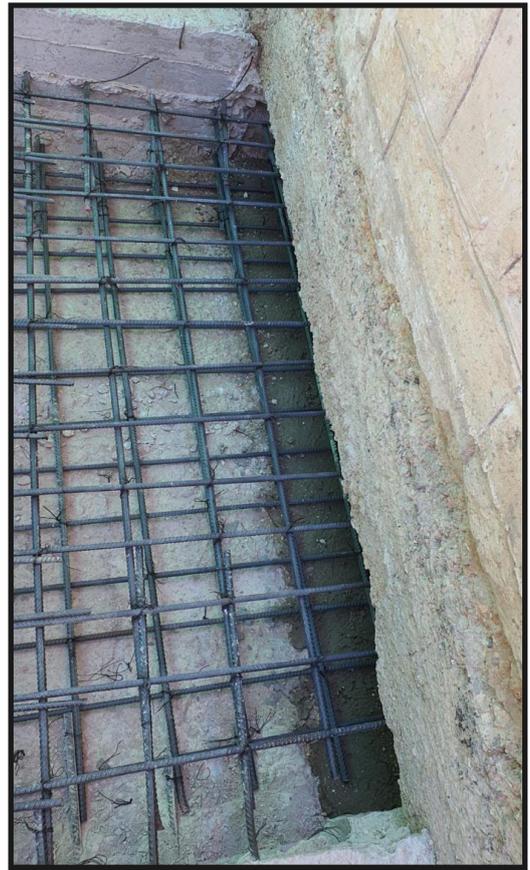
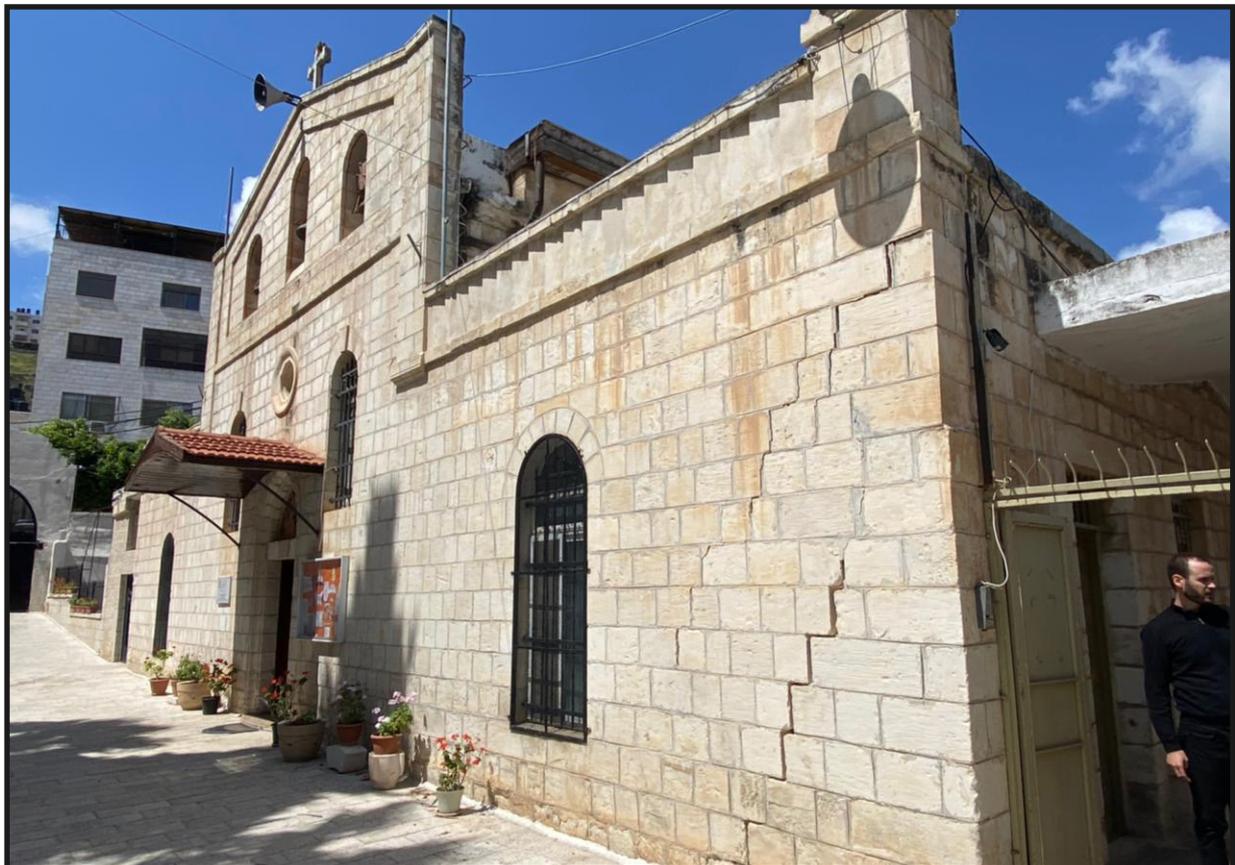
**Photos
Before**

The Latin Church building in Rafidia, Nablus suffered from serious structural cracks and damages in the bearing and facing wall elements of the buildings. A central longitudinal crack was apparent at the roof slab of the passages' arched vaults with vertical and inclined cracks in the stone bearing-walls. After inspections, results revealed that the building was in a deteriorating condition and structurally compromised. Rehabilitation works carried out for the building components in the past did not help in ceasing the progress of deteriorations. Remedial measures were needed to repair the building and restore its stability and safety in addition to some urgent reinforcements at both the hall and the youth center. The project focused on implementing temporary and urgent repairs to improve the stability and performance integrity of the church hall and youth center to ensure structural safety. The project included the following works:

-Demolishing works: included dismantling the existing masonry stone wall separating the entrance from the inner yard -using manual tools -of approximate height (2 -2.4 meter); including removal of its foundation and transporting all debris to another site as approved by the authorities.

-Propping system works: included supplying and installing temporary propping system before excavating for underpinning works. Probs made from 5-ton capacity and timber joists (10x5cm) spaced 80cm in both directions -to the northern and eastern sides of the church; activity hall and praying hall.

-Underpinning system works: included dismantling the existing stone and concrete pavers

at the underpinning excavation areas, manual excavation in alternate segments as sequenced on the drawings, placing 5-ton sacrificial probs in sequence, placing footer reinforcement raised on concrete spacers cubes 10x10x10cm and placing wall reinforcement, in addition to using high slump self-compacting concrete 8200.
